ARCHIMEDES

Ústí nad Labem

R49.1 – Safety Audit in Ústí nad Labem

31 August 2011

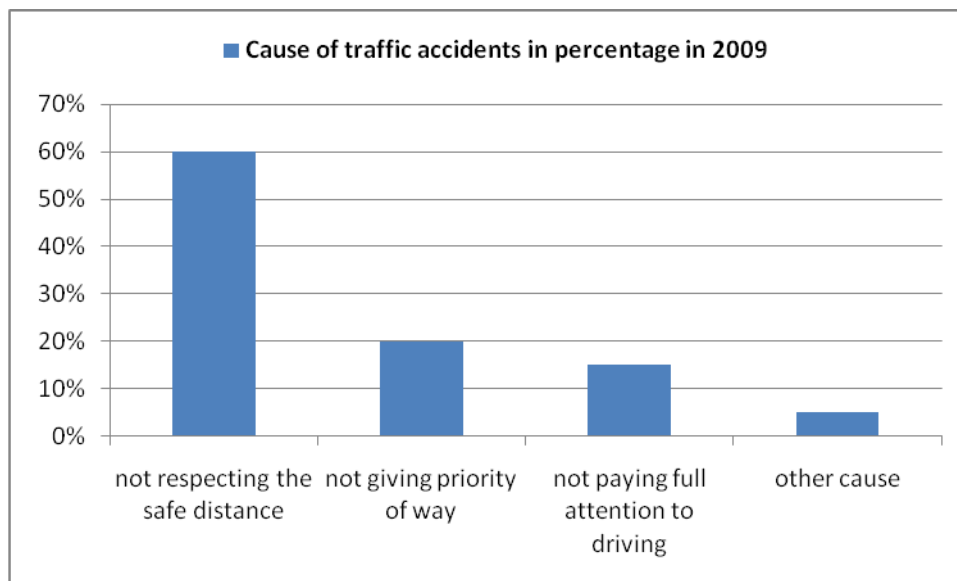
Figure 1 - Cause of traffic accidents in Ústí nad Labem in 2009

Approximately 60% of traffic accidents were caused by not respecting the safe distance between vehicles. Another major cause of traffic accidents was not giving priority of way (20%) and accidents caused by negligence (15%) - mainly by not paying full attention while driving and parking.

When not respecting the safe distance, approximately 80% of accidents happen due to the fact that the driver gives priority to pedestrians on a pedestrian crossing and the driver behind is unable to avoid crashing into the stationary car in front of him/her. Another cause is a pedestrian entering the road in front of a vehicle without looking. The remaining 20% of accidents happened when a vehicle enters the road in front of another vehicle, which manages to avert crashing by stopping early, but the following driver lacks sufficient distance to react and therefore causes an accident.

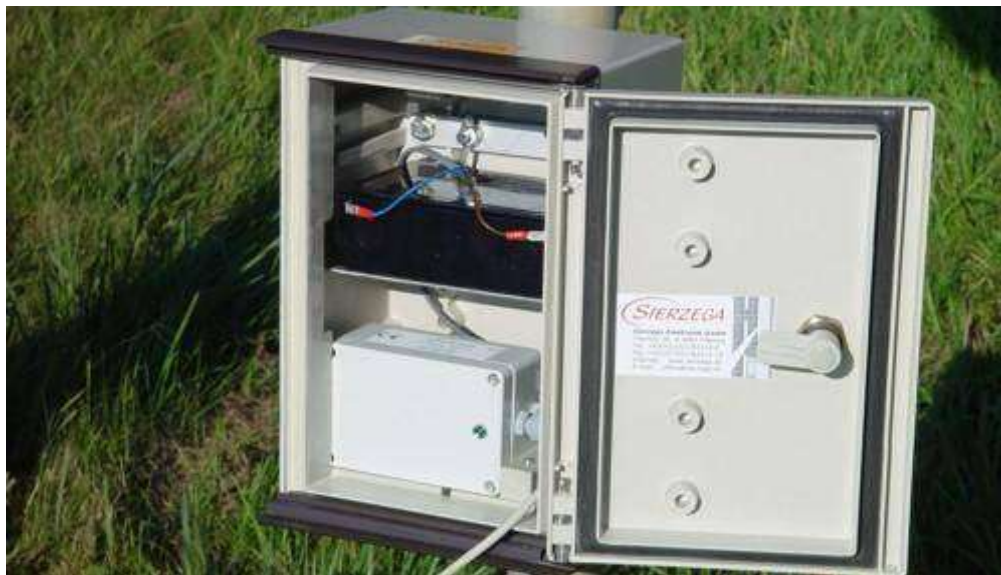
Figure 2 - Measuring equipment Sierzega SR

The advantage of automatic traffic counting equipment is the fact that measurements can be realised in longer time periods with relatively high accuracy (the error is around 10%) and objective values (measuring medium does not affect road users).

Outcomes of the measurements are information on the composition of traffic flow based on measuring vehicle lengths (1st category – motorcycles, 2nd category – cars, 3rd category – freight vehicles, 4th category – buses and trucks with a trail), their speed in km/h, the exact time of measurement, the date and directionality of each vehicle.

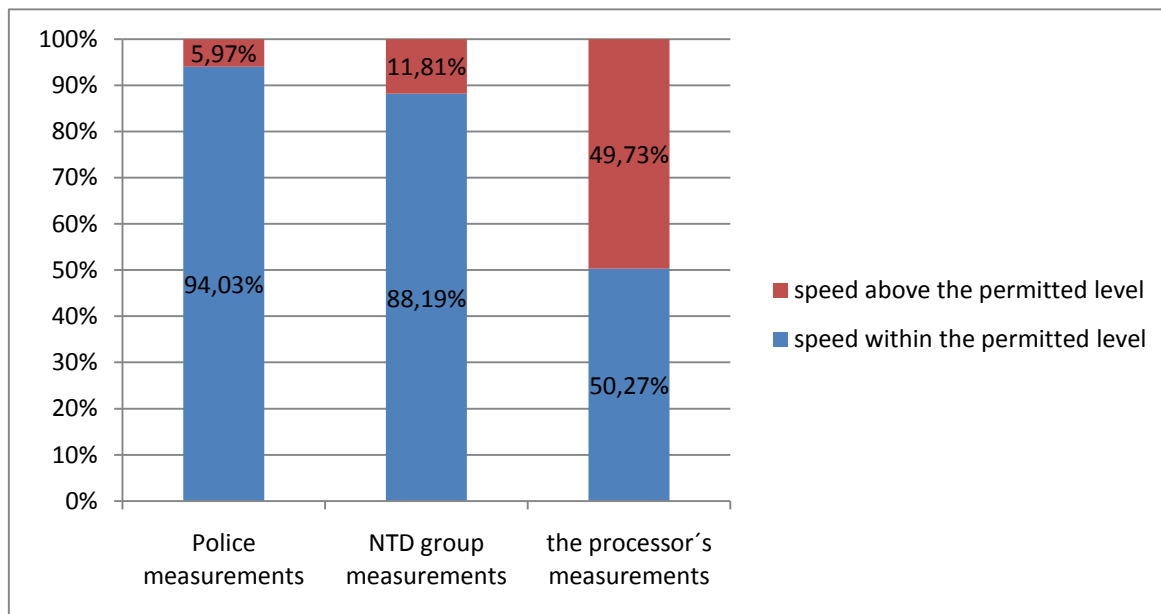
Figure 3 - Comparison of speed measurements realised by different partners

Comparing the speed measurements realised by the Municipal Police, the NTD group and the processors, there is apparently a wide variation of results (see Figure 9). 94.0% of vehicles follow the speed limit according to the Municipal Police, 88.2% of vehicles according to the NTD group and only 50.3% of vehicles according to the processor. These differences may be caused by different means of measurements - the processor used quite imperceptible device placed on the post of a vertical traffic sign by the road, while the Municipal Police measured passing vehicles from a car parked by the road, which may be perceived as a warning signal for drivers. Stationary devices used by the NTD group were also apparent and marked by speed warnings on both horizontal and vertical traffic signs. Furthermore, the difference may be caused by different tolerances of the measuring equipment used by individual partners.

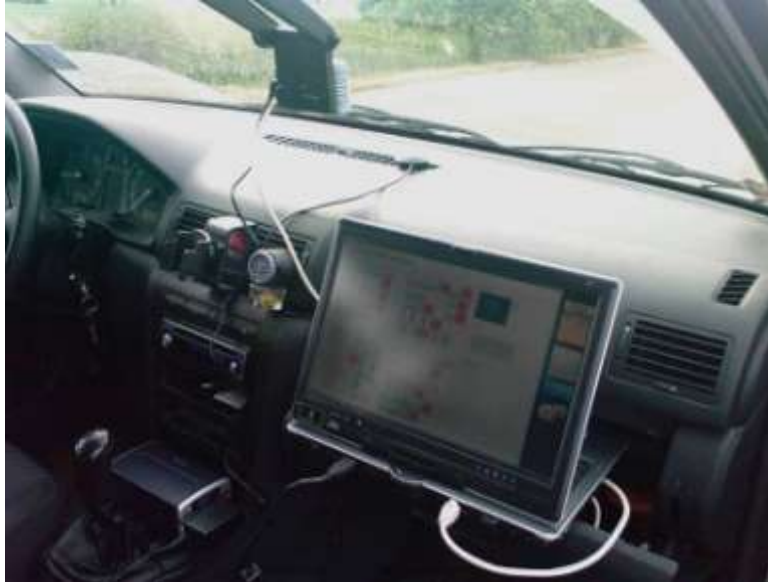
Figure 6 - Hardware attached in the vehicle

- PC – Laptop, tablet category running with MS XP, MS Vista or Microsoft Windows 7
- Full HD camera with a holder attachable into the vehicle
- GPS (or DGPS) with the protocol NMEA connected via a serial port or USB port
- A car power inverter for powering the CL adapter
